## Safety Lamps and Colliery Explosions

JAMES ASHWORTH, M.E., Mount Chaddesden, England.

(Presented at the Annual Meetings, 4th, 5th and 6th March, 1902.)

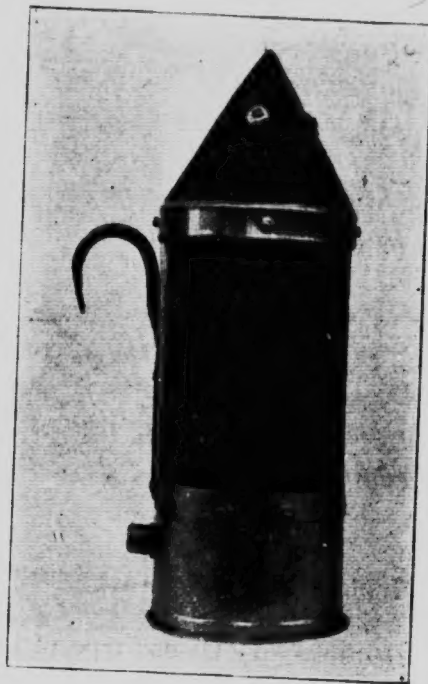
FIG. I.—Scotch Gauze Lamp.

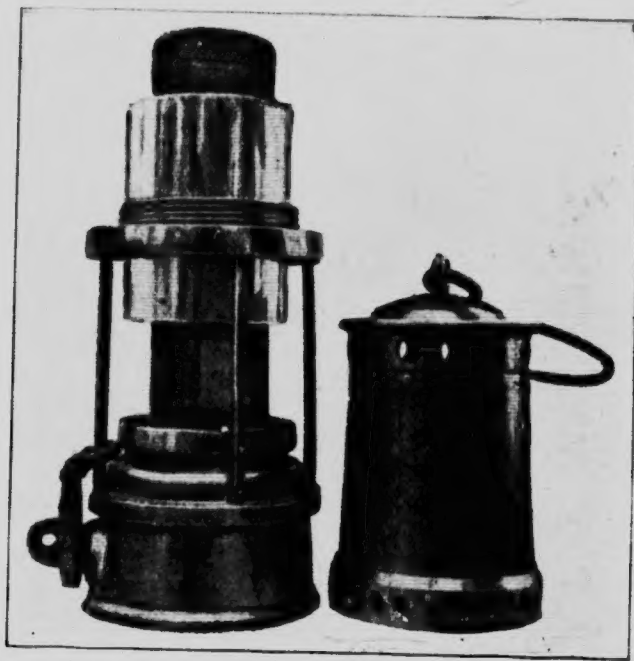
FIG. III.—Cambrian Davy Lamp for Firemen, showing glass part raised and the bonnet removed.

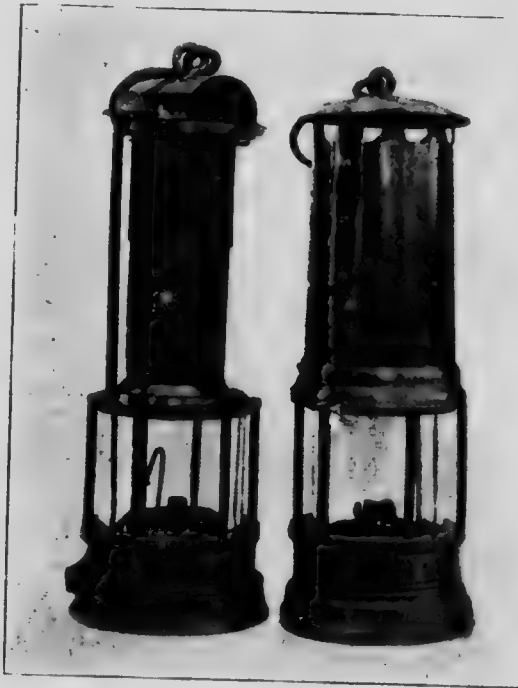
FIG. IV.—Clanny Lamps.

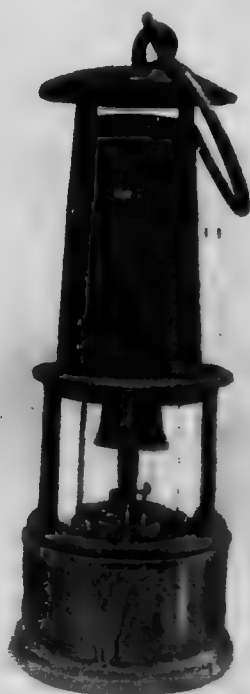
FIG. VI.—Mueseler Lamp.

At the Whitfield Colliery, North Staffordshire, in 1886, a Mueseler lamp (Fig. VI), which is a safer lamp than the Clanny, and is under ordinary circumstances automatically extinguished by an explosive current, failed entirely to resist what may be termed a very practical test. The lamp in question was hung on the side of a heading in the Cockshead mine (which is a thick coal having an inclination of about one in four), and the collier who was working by its light was moving

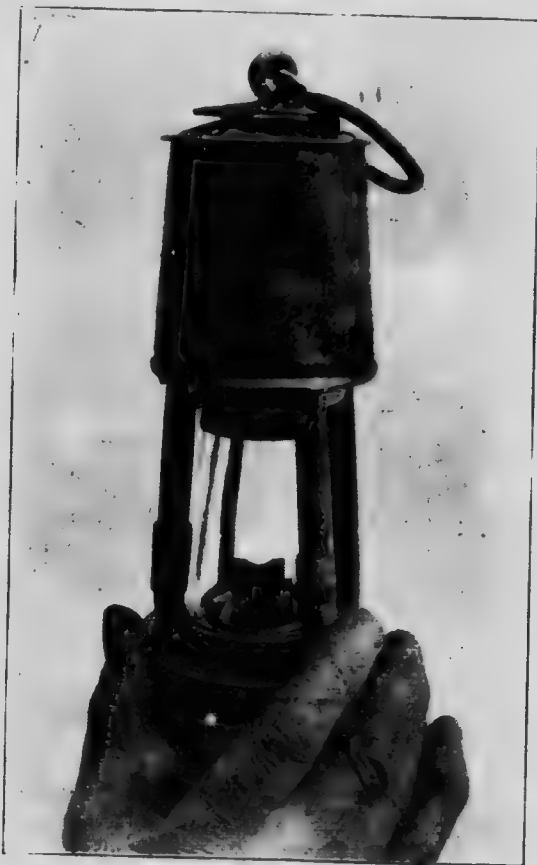
FIG. VIII.—Ashworth's patent Gray, Deputy or Fireman's Lamp. Showing mode of manipulation when testing for firedamp.
